Five-Year Review Report

Second Five-Year Review Report

National Presto Industries and the Eau Claire Municipal Well Field

September 2002

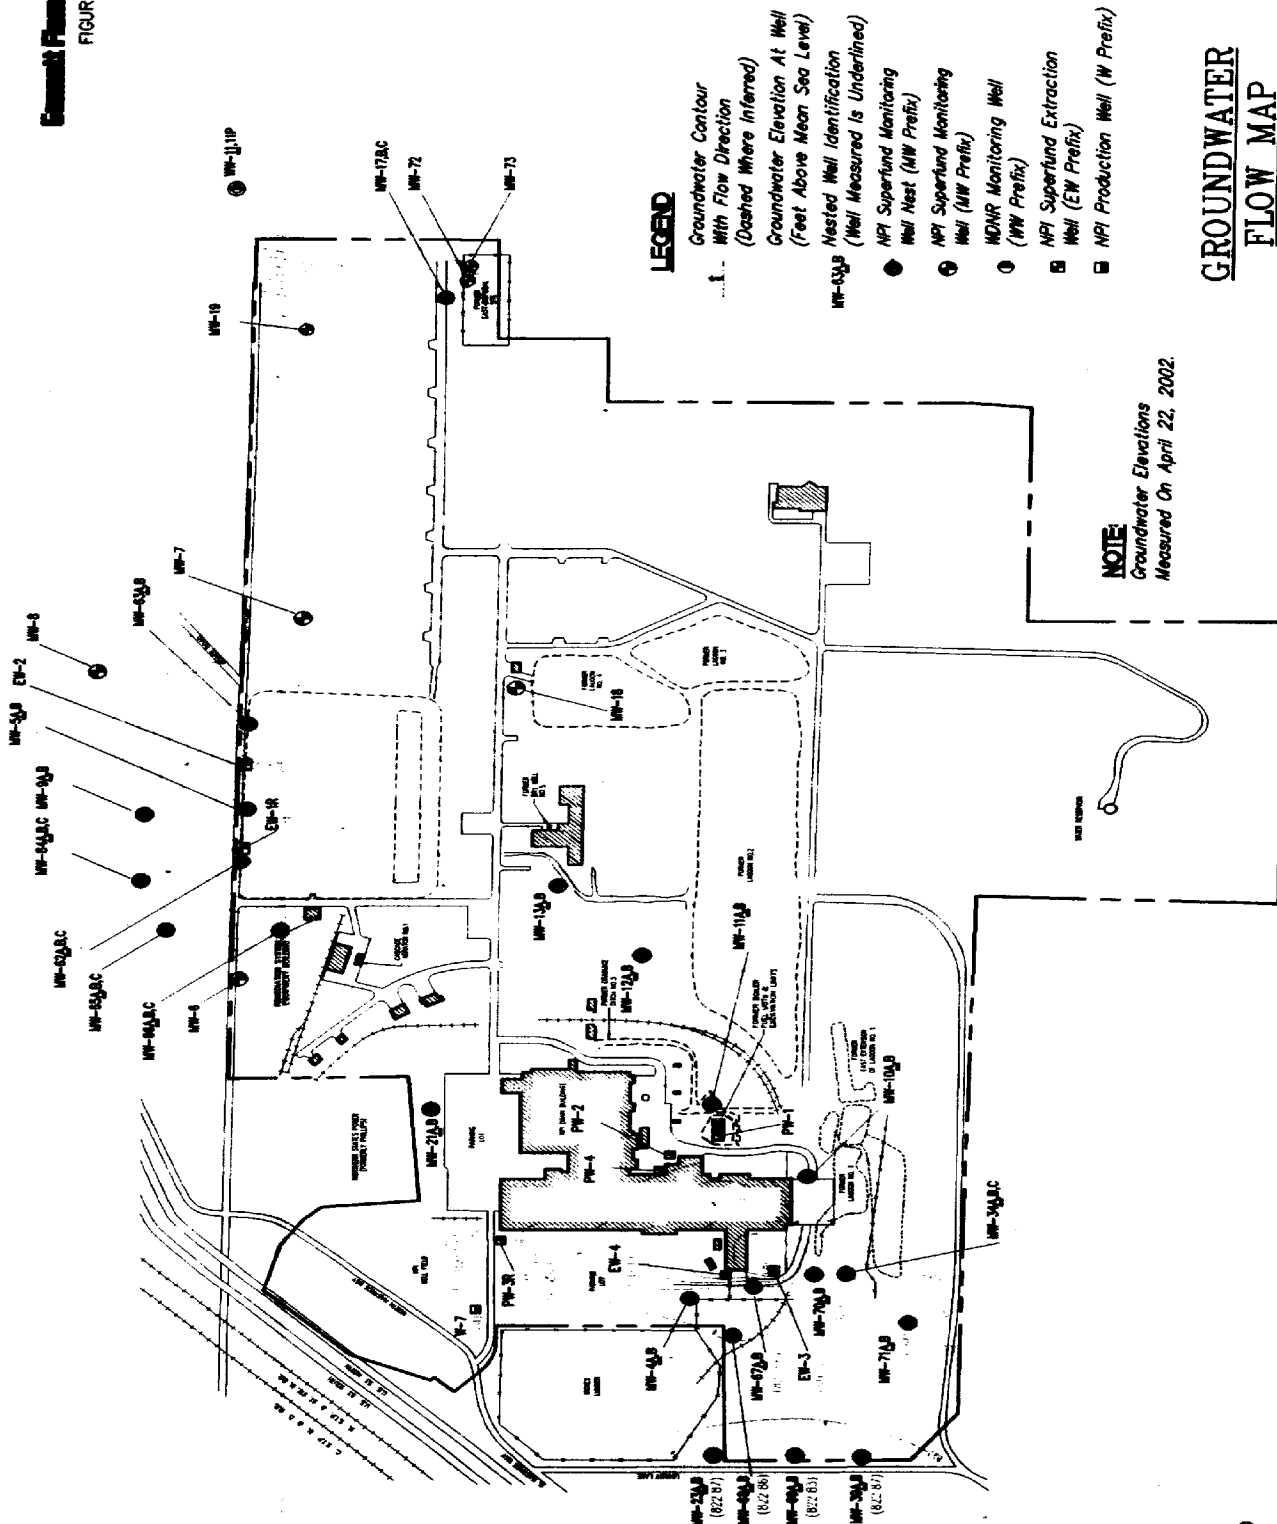
GROUNDWATER FLOW MAP (APRIL 2002)

Currently, a total of 38 wells (22 on site and 16 off site) are being monitored in this plume, excluding the eight EC wells at the ECMWF. As noted above, the groundwater flow direction has remained constant. Figure 5 is a groundwater flow map for this area of the site using data from the April 2002 sampling round. Table 6 presents the analytical results for the Southwest Corner wells since August 1997. In general, the concentrations are stable or decreasing. Since August 1997, four on-site wells have contained concentrations of one of the five VOCs of concern above the U.S. EPA's Maximum Contaminant Levels (MCLs)/WDNR's enforcement standards (ESs). Most of the concentrations in these wells are relatively low and decreasing, and one of these four wells has not had an MCL/ES exceedance in four years. Three wells, MW-34A, MW-70A, and MW-70B, are an exception. These wells are all located west of former Lagoon #1 and south of extraction well EW-3. They were the three wells identified in the last Five-Year Review as having exceedances of the MCLs/ESs. VOC concentrations in these wells have recently begun to show an upward trend.

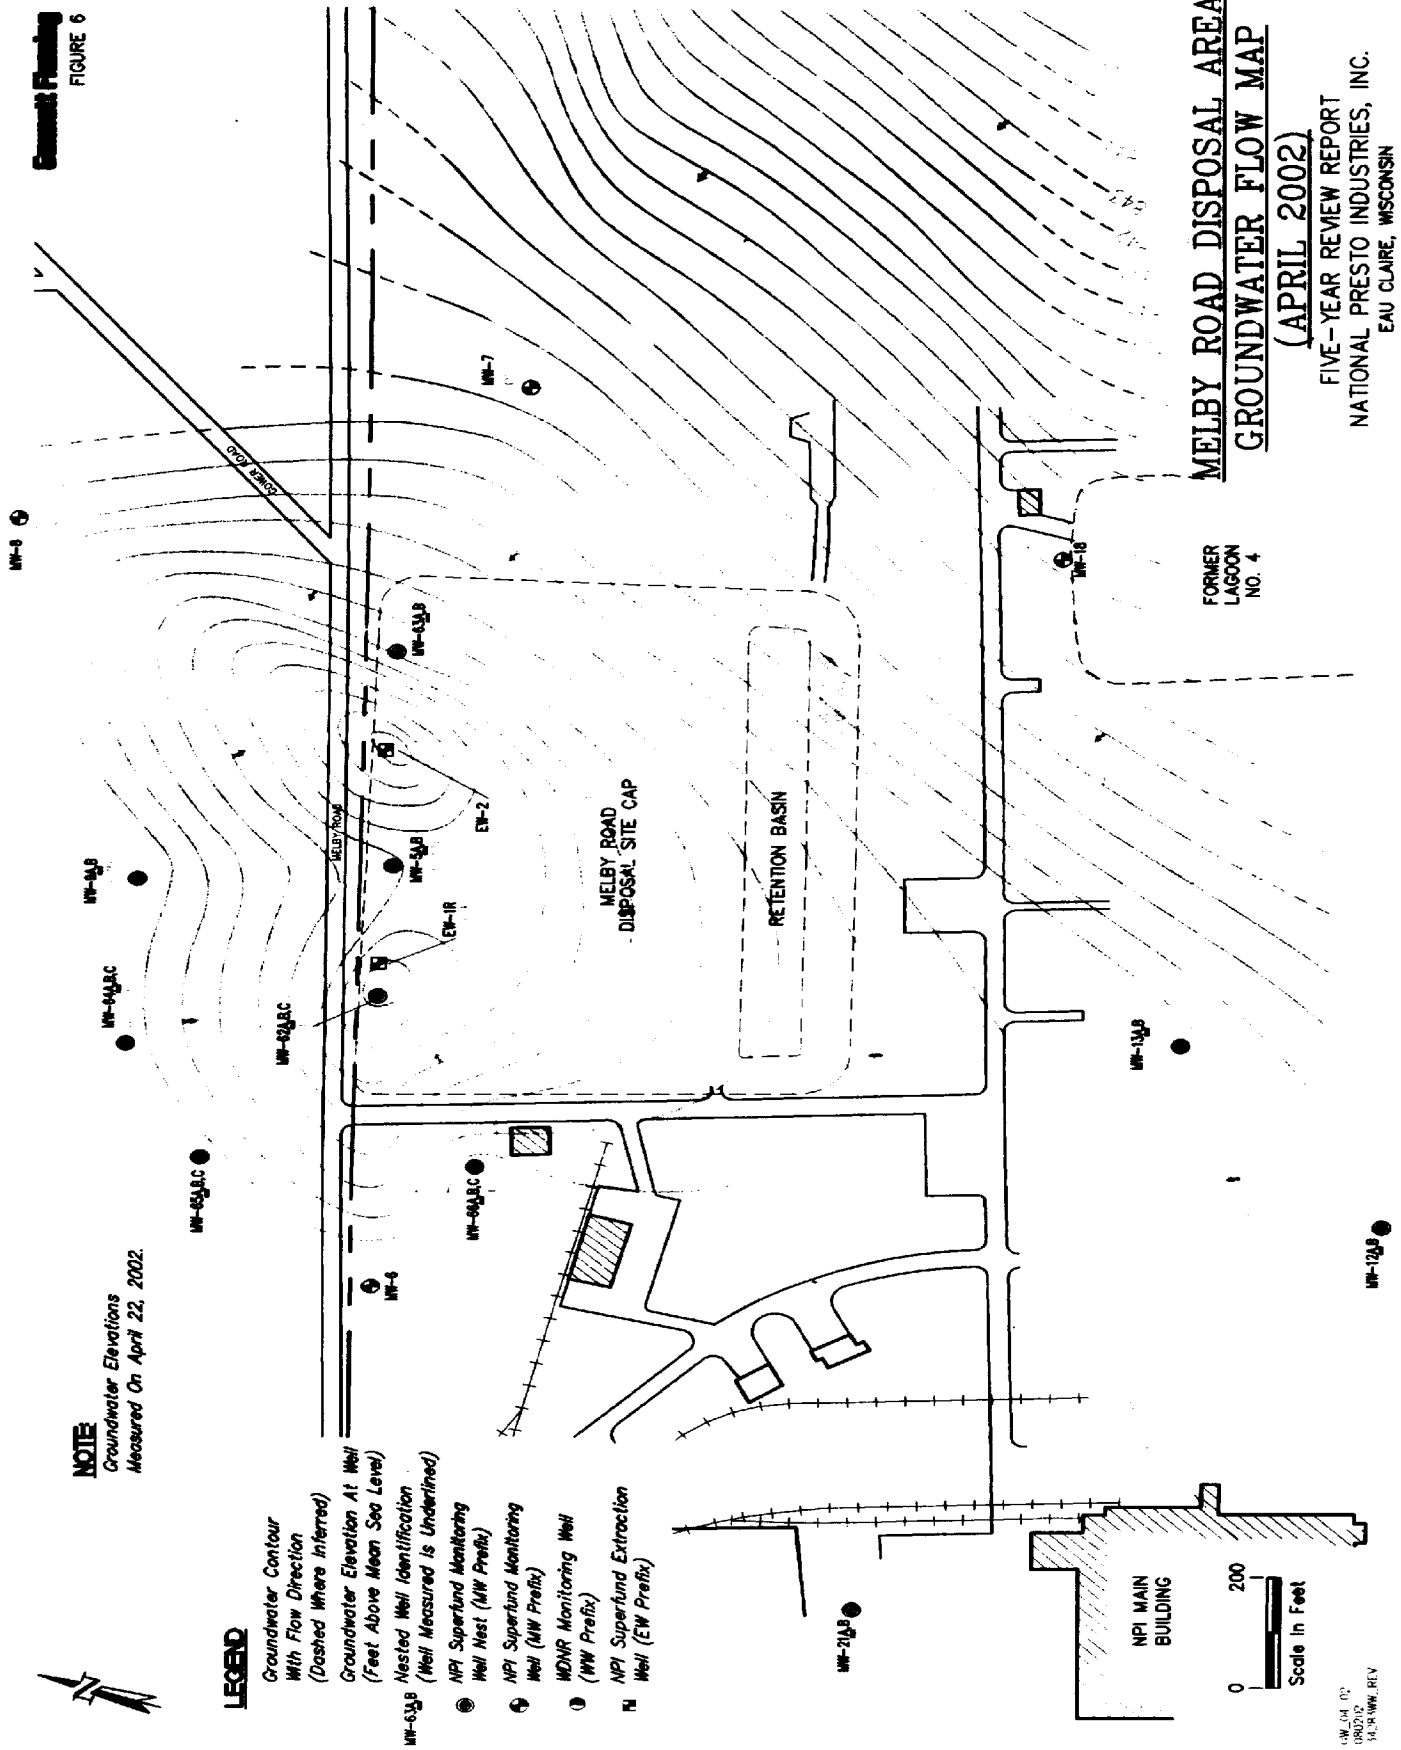
**MELBY ROAD DISPOSAL AREA
GROUNDWATER FLOW MAP**

Monitoring of 18 monitoring wells (7 on site and 11 off site) continues at this part of the site. Contaminant concentrations in all wells have remained steady or decreased since 1997. As was the case five years ago, none of the wells have contained concentrations of any contaminants above their MCLs/ESs, which means that there have been no exceedances since at least 1994. Eight of the wells (3 on site and 5 off site) have had concentrations above the PAL. It should be noted that half of these "PAL exceedances" are below the limit of quantitation. None of the remaining ten wells have had concentrations above the PAL since the last Five-Year Review, and two of them are consistently below the detection limit. Table 9 contains the analytical results for the MRDS monitoring wells since August 1997. As noted above, the direction of groundwater flow beneath this portion of the site has remained constant during the past five years. Figure 6 is a groundwater contour map for the MRDS constructed using data from the April 2002 sampling round.

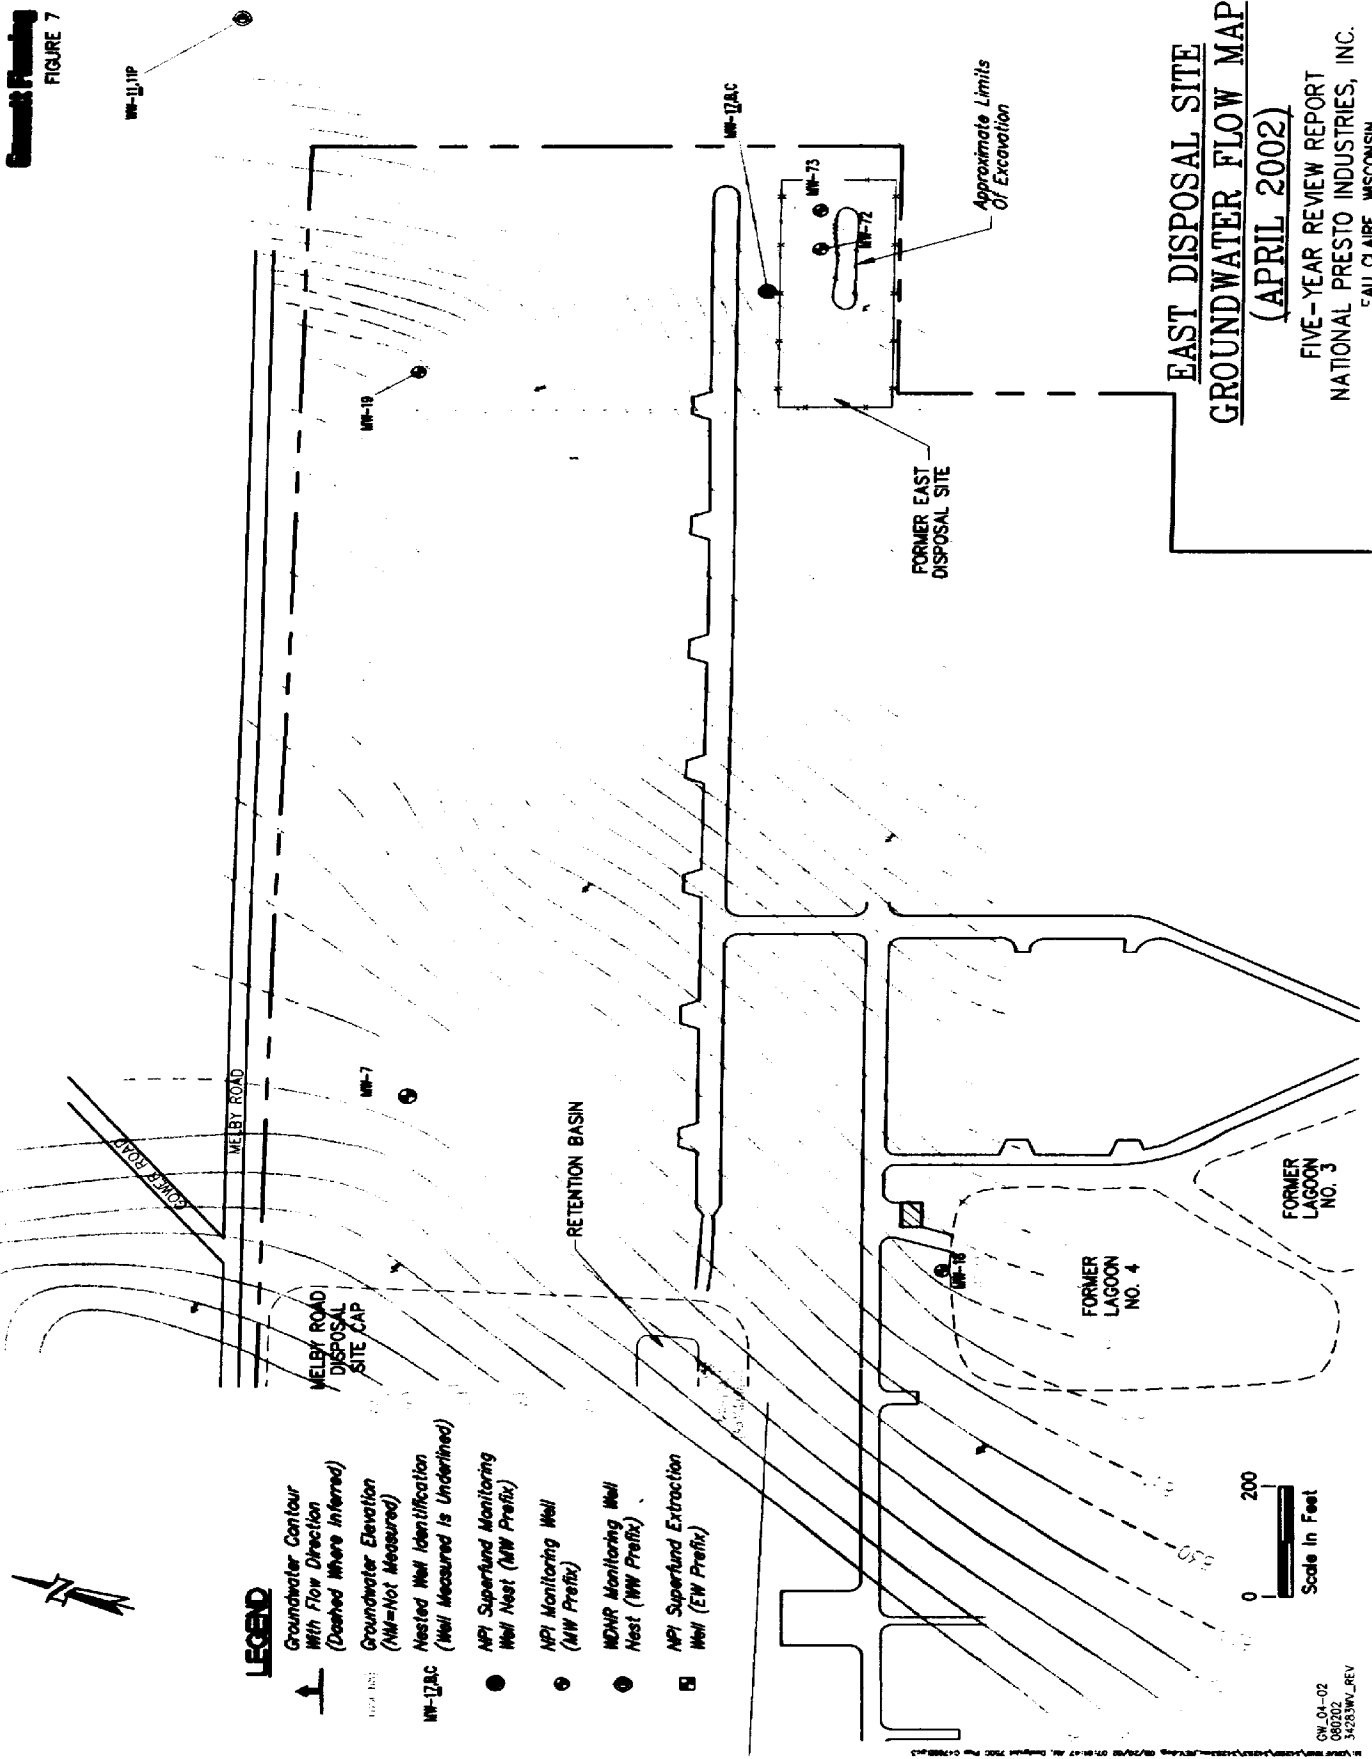
EAST DISPOSAL SITE
GROUNDWATER FLOW MAP
(APRIL 2002)
FIVE-YEAR REVIEW REPORT
NATIONAL PRESTO INDUSTRIES, INC.
EAU CLAIRE, WISCONSIN

Table 11 contains the analytical results for the EDS monitoring wells since August 1997. As noted above, the direction of groundwater flow beneath this portion of the site has remained constant during the past five years. Figure 10 is the most recent groundwater contour map for the EDS.

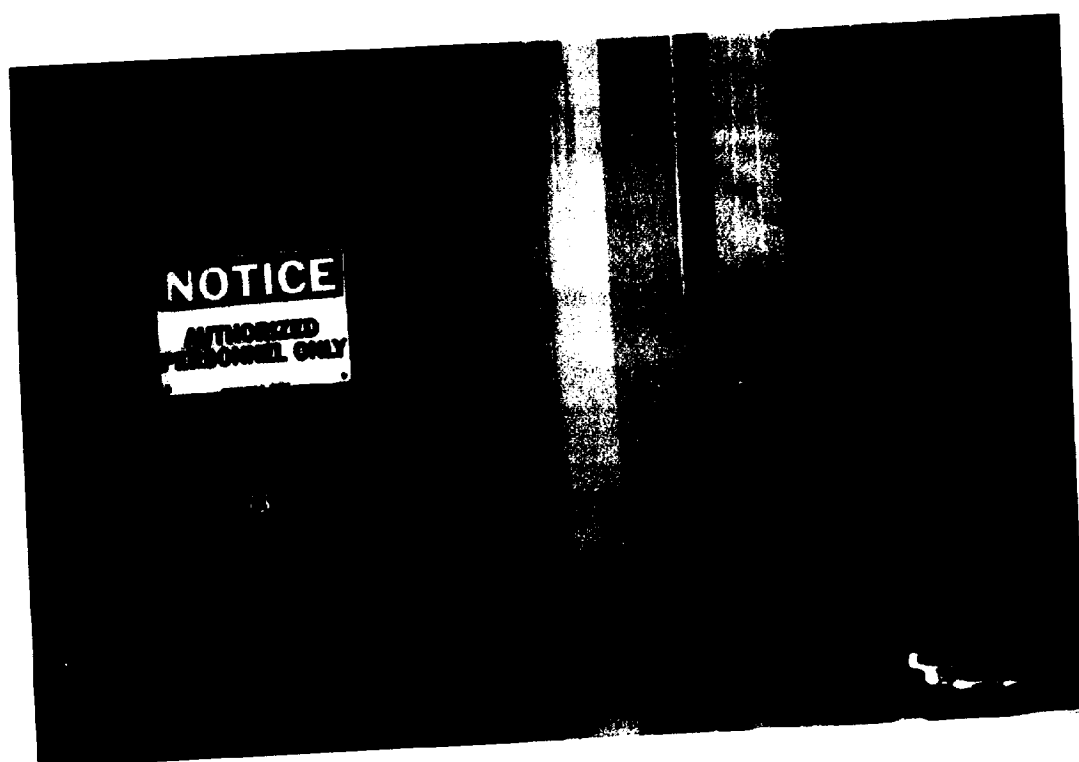
TREATMENT BUILDING

The attendees observed the extraction wells in the Southwest Corner of the Site. The attendees observed the two cascade aerators that are used to remove VOCs from the captured water prior to discharge.
